# North Creede Stream Stability & Flood Mitigation

**DRAFT** Preliminary Basis of Design Report

PREPARED FOR: Headwaters Alliance

PREPARED BY: WaterVation

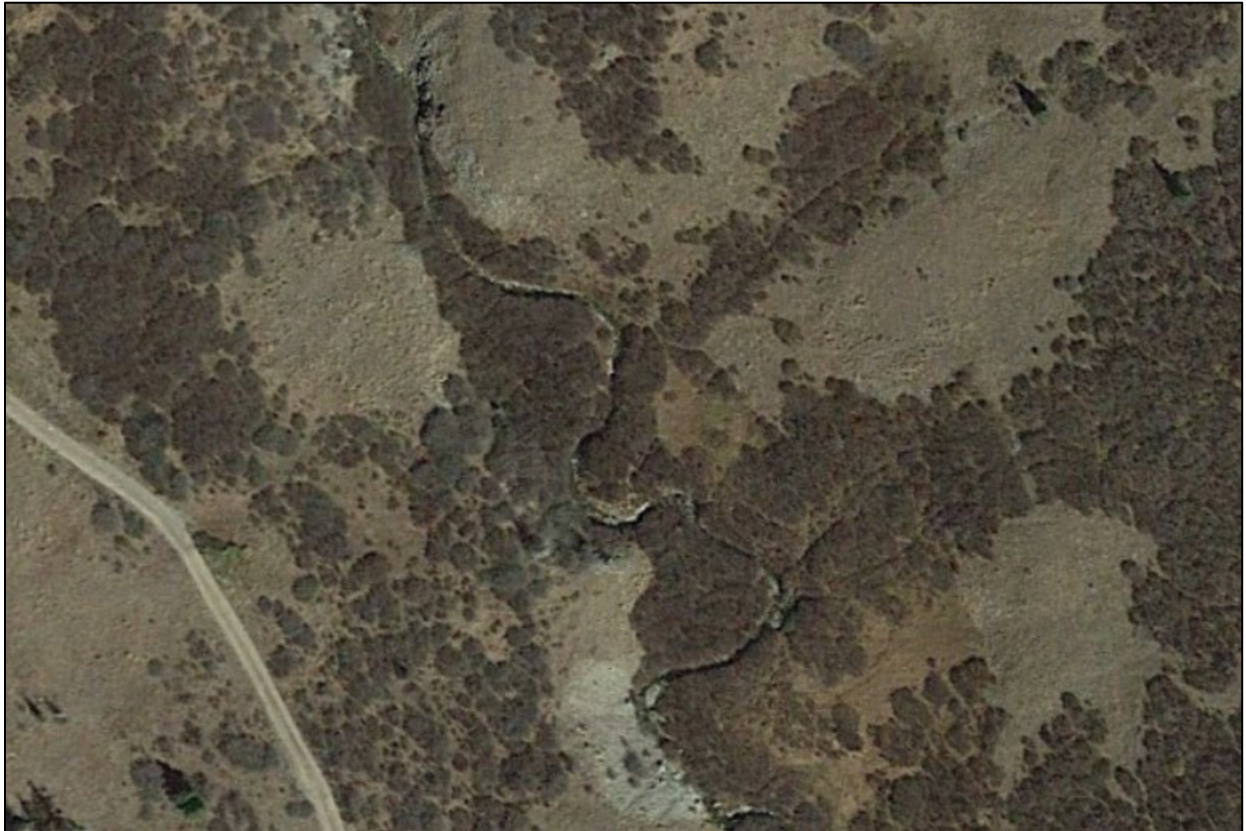
*Picture 1. West Willow Creek Upstream of Equity Mine*

In the headwaters, West Willow Creek exists as a sinuous stream with a large and well vegetated floodplain (Picture 1). At this location West Willow Creek is generally in a stable condition.

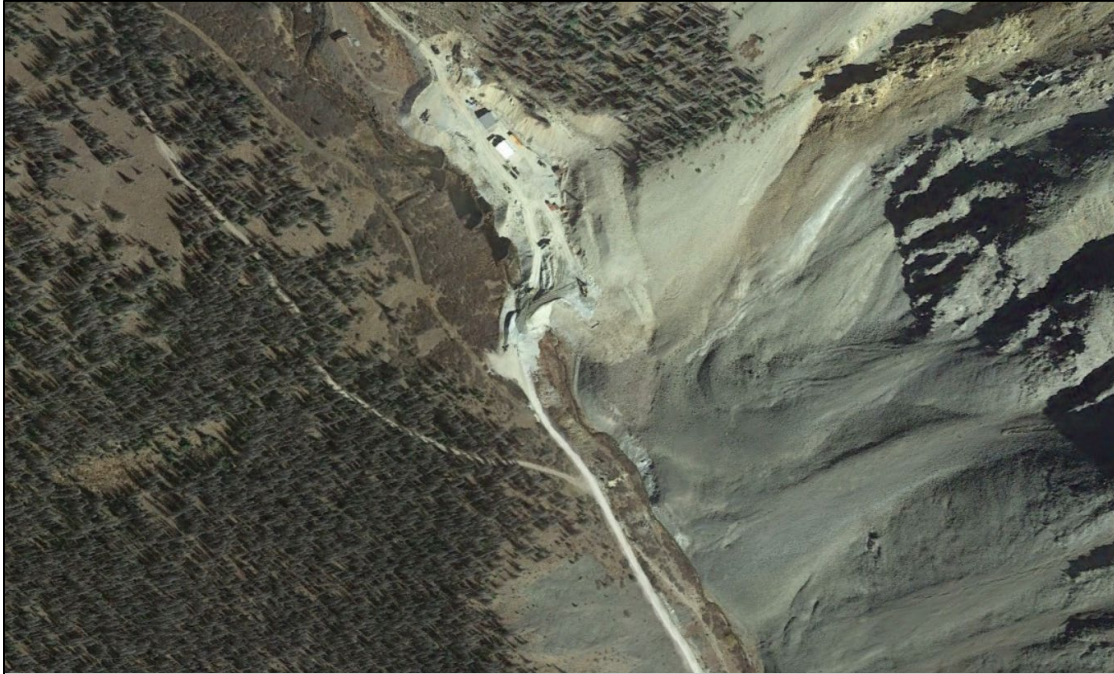
*Picture 2. West Willow Creek at Equity Mine*

Near the Equity Mine West Willow Creek becomes confined and is influenced by tailings produced by the Equity Mine (Picture 2).

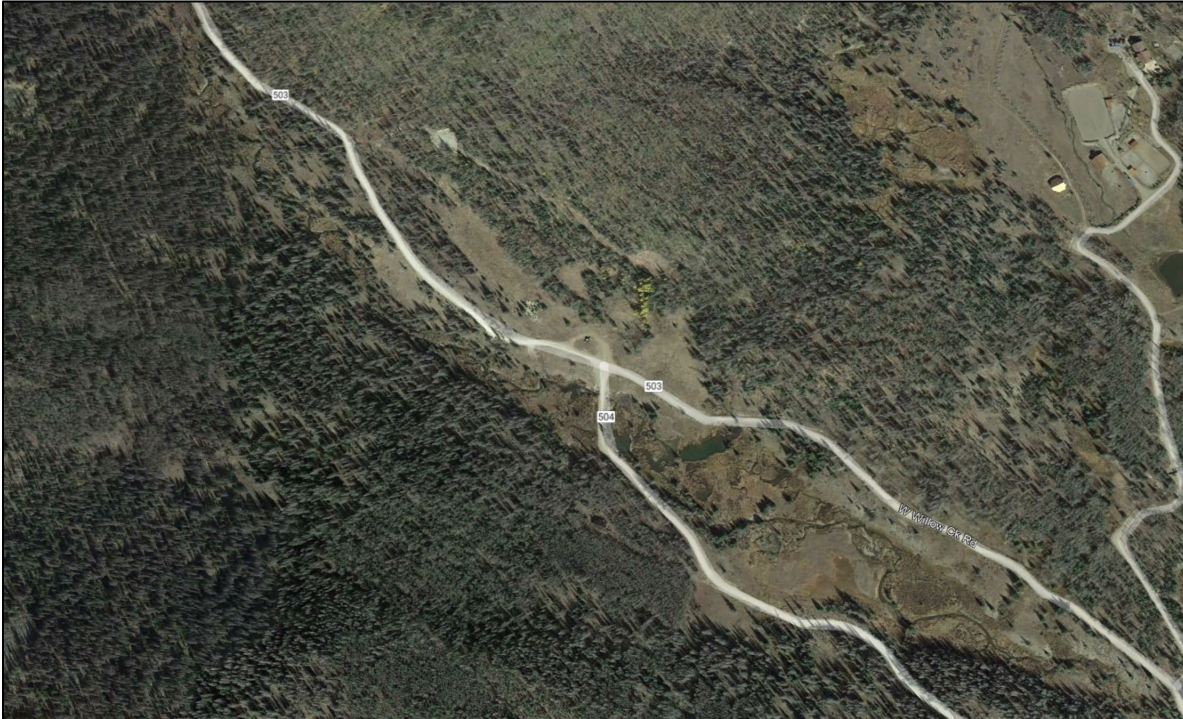
*Picture 4. West Willow Creek Upstream of CR 503/504 Intersection*

The roadway crossing at the intersection of County Road 503 and 504 is causing localized erosion and significantly influencing the pattern of West Willow Creek. However, upstream of this location, West Willow Creek exists in a relatively stable form with a moderately wide, well-vegetated floodplain (Picture 4).

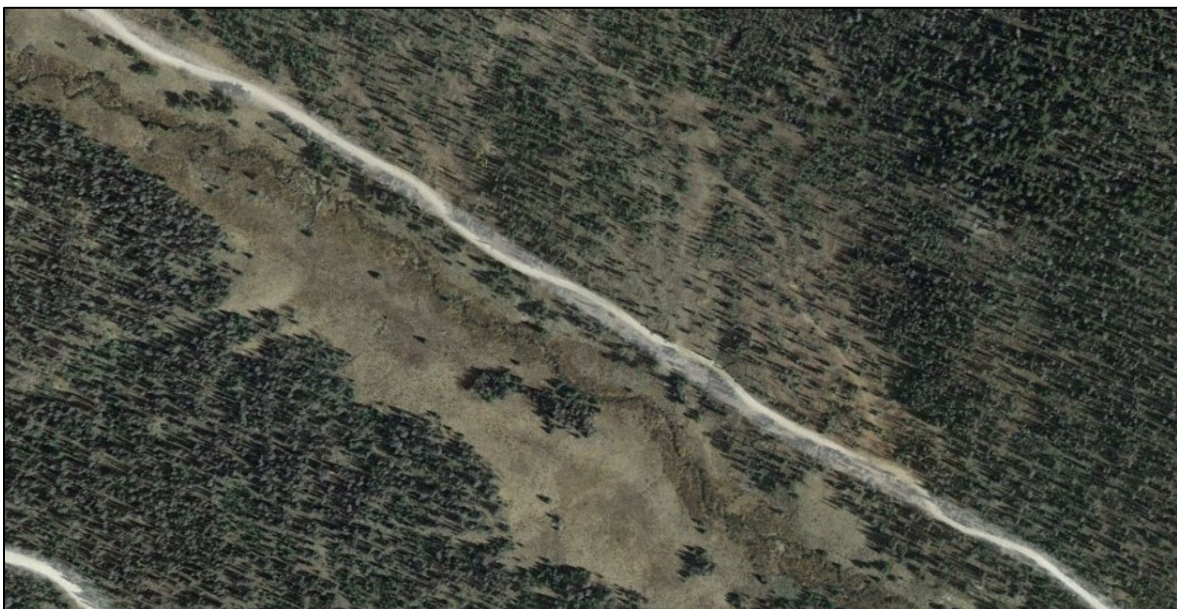
*Picture 5. West Willow Creek Downstream of County Road 503/504 Intersection*

The stream and floodplain downstream of the intersection of County Road 503 and 504 are in relatively stable condition, but with a much narrow floodplain (Picture 5).

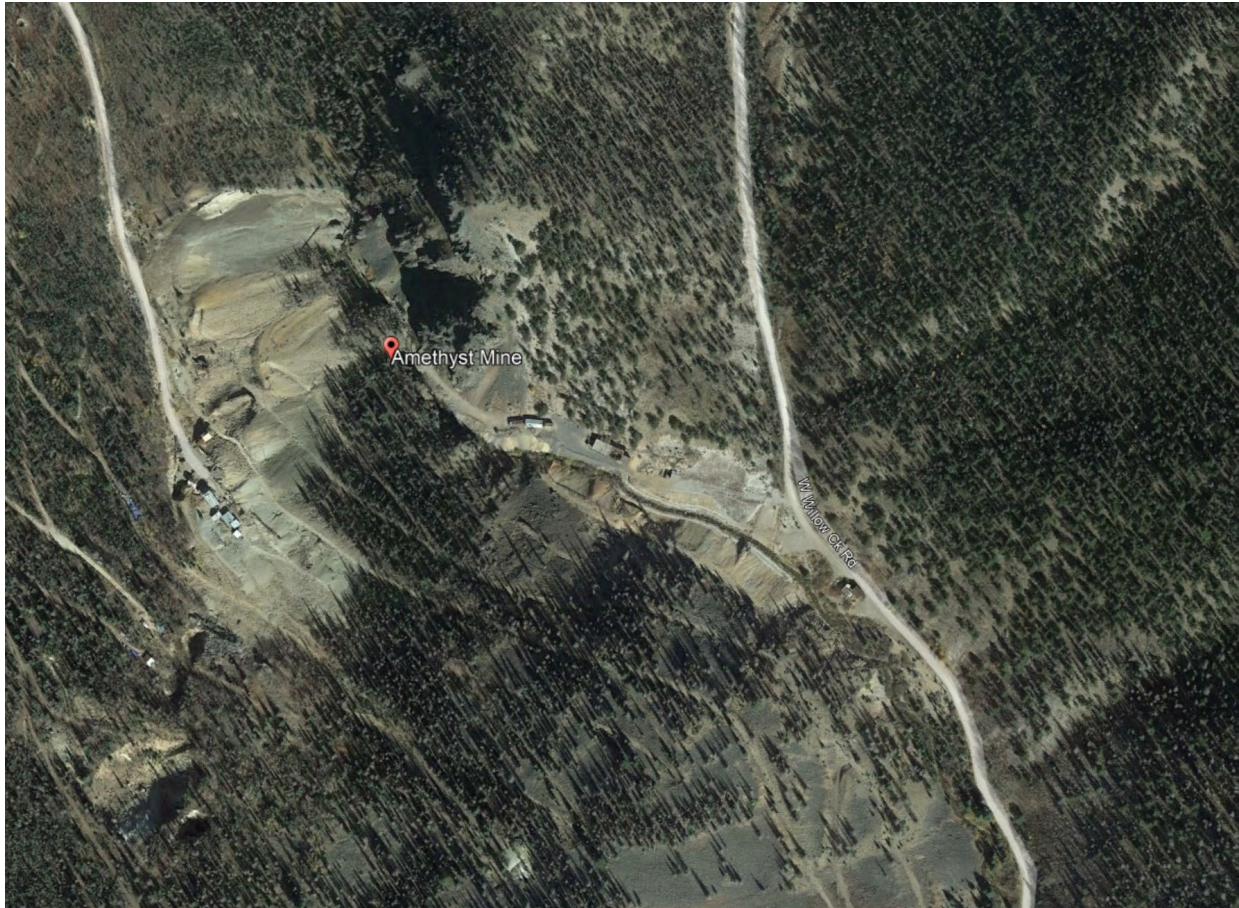
*Picture 6. West Willow Creek Near Amethyst Mine*

Most of the stream stability issues begin near the Amethyst Mine ( ). Downstream of this point the stream becomes very incised and also coincides where most of the historic mining activity took place.

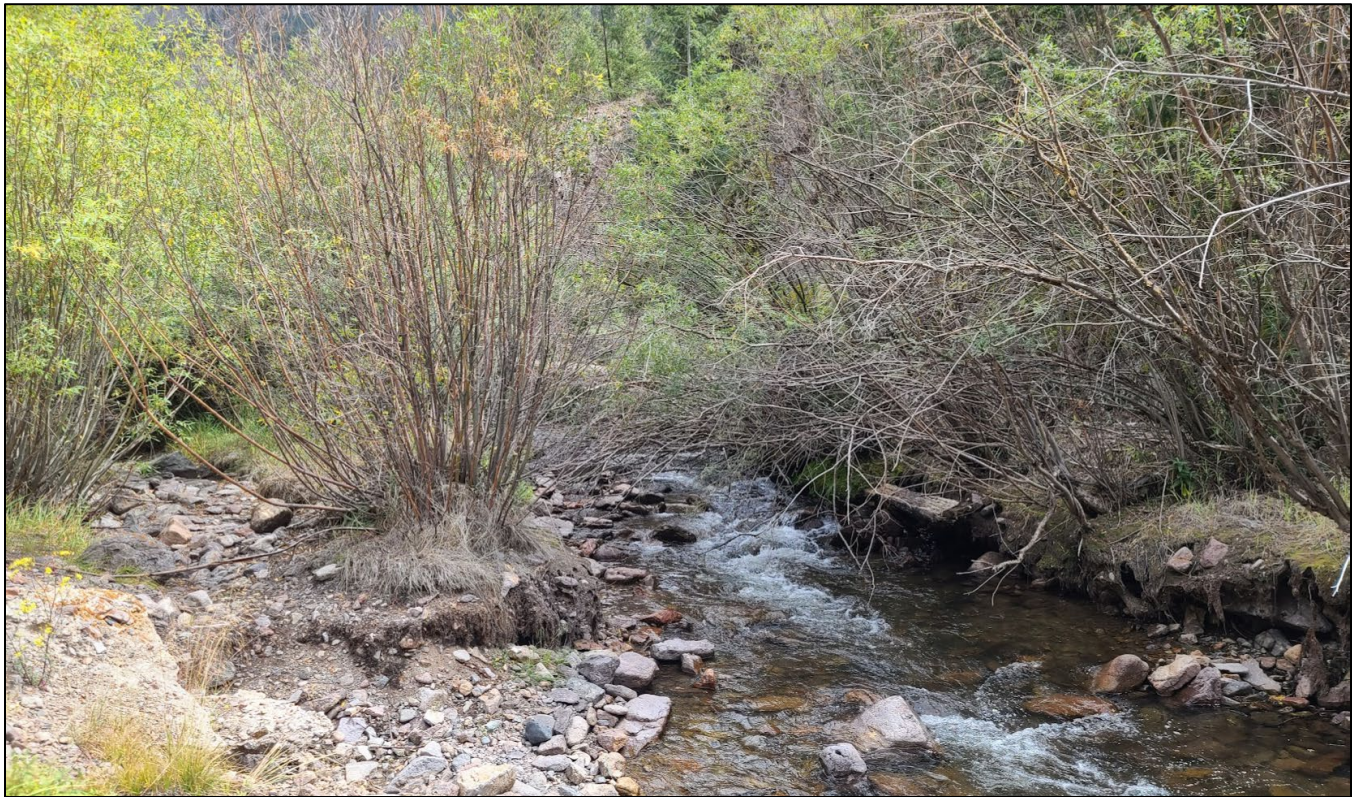
Picture 7. East Willow Creek

The East Willow Creek subwatershed has a drainage area of approximately 20.8 square miles and can generally be characterized as a confined alluvial valley. East Willow Creek shows evidence of flood damage; however, the stream corridor is showing signs of recovering in many (but not all) locations through natural processes. A dominant low flow and bankfull channel can be seen in many locations, the channel pattern is generally in a stable state as evidenced by well-vegetated overbanks, and the channel profile is beginning to show signs of bedform complexity (establishment of riffles, steps, and pools).

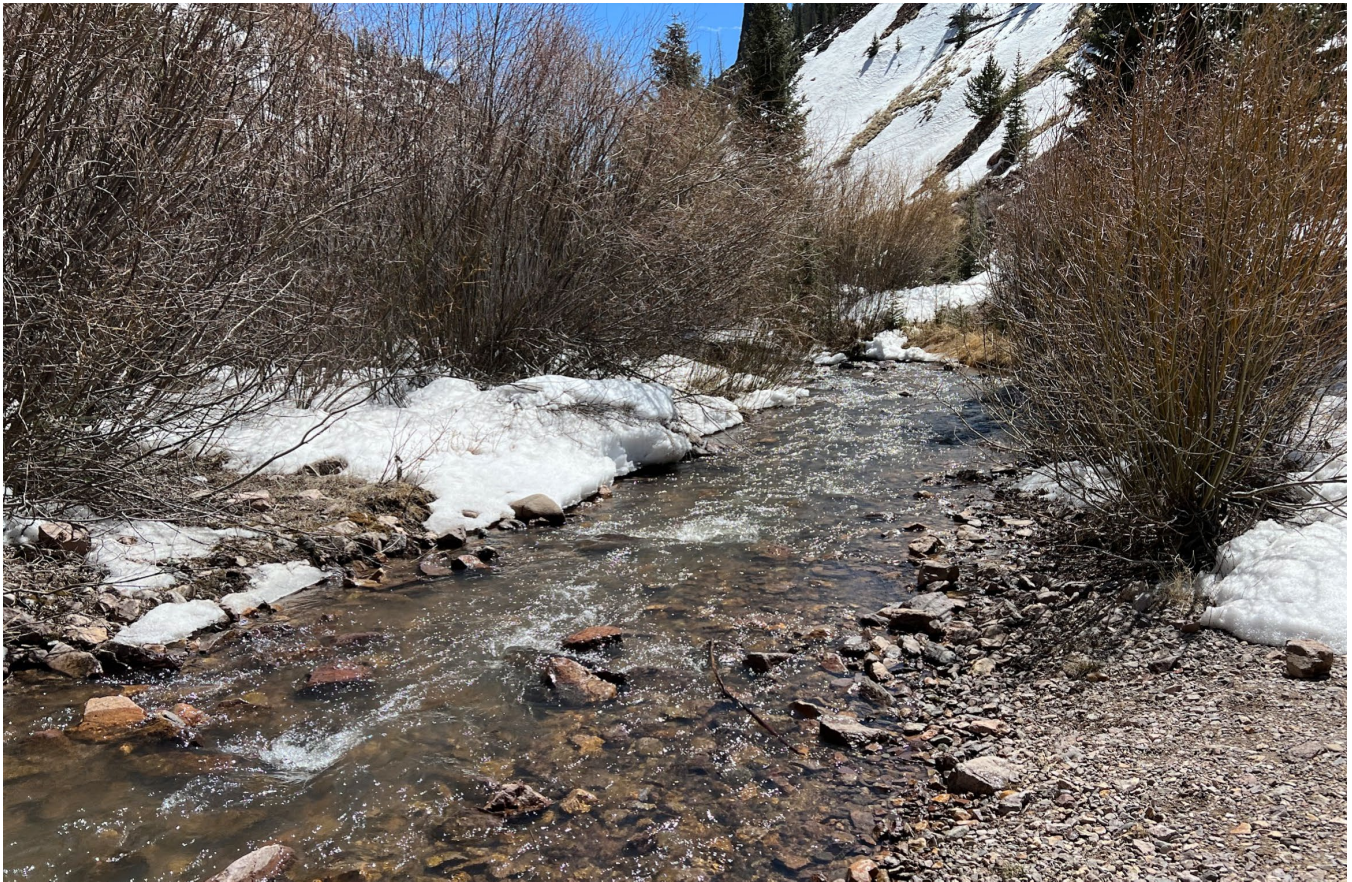
Figure 6. Reference Cross Section on West Willow Creek

Field-based estimations of bankfull flow were made on West Willow Creek at a location where the stream cross section was in stable condition, and also appeared to have been stable for the past several years based on review of historical aerial imagery (Figure 5). The drainage area at this location is approximately 12.4 square-miles and the estimated bankfull cross section area is 11.9 square-feet. The bankfull cross section area was scaled based on drainage area in order to estimate bankfull flow at the Project site. The results of this analysis showed that the bankfull flow is approximately 140 cfs.

A bankfull flow of 140 cfs is recommended for this Project based on a general agreeance of results between the regional curve, statistical analysis of USGS gage data, and field-based estimations of bankfull flow.

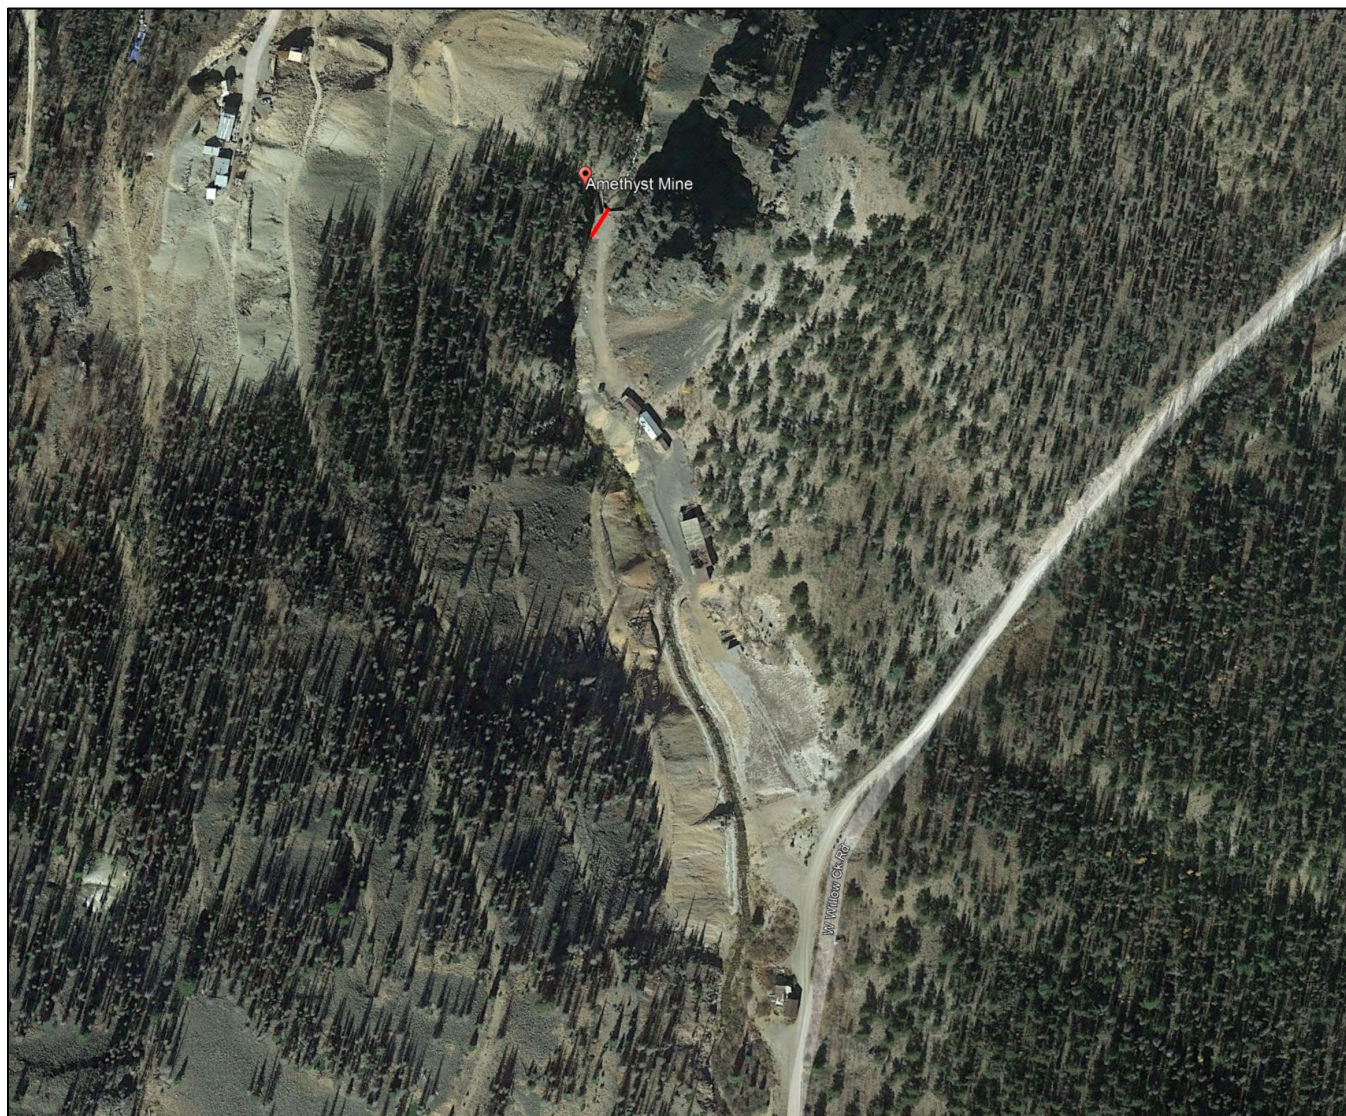
Figure 11. Amethyst Mine Culvert

The existing culvert under the access road for the Amethyst 5 Mine (red line shown in Figure 10) is currently impeding stream flows and trapping flood debris. The constriction of flood flows is causing downstream channel degradation and the trapping of flood debris is partially blocking the entrance to the culvert. Both of these conditions are exacerbating flood-related risks and should be mitigated.

There are a couple of options to address the issue at this location, both are contingent on the removal of the existing culvert and debris screen. The crossing could then be replaced with a low-water crossing or three-sided soft bottom culvert that spans the bankfull channel. With either option, the downstream end of the crossing could be enhanced by transitioning stream grade with a step-pool boulder structure to more gently transition flows and reduce erosion risk.

The construction cost associated with either improvement option will likely range between \$50,000 to \$100,000.
